# Manhole Inspection Summary

Manhole # S21M\_\_028MH

Insp Date: **2/23/09 1:51 PM**

**Location** Address: **510 S MONROE ST**

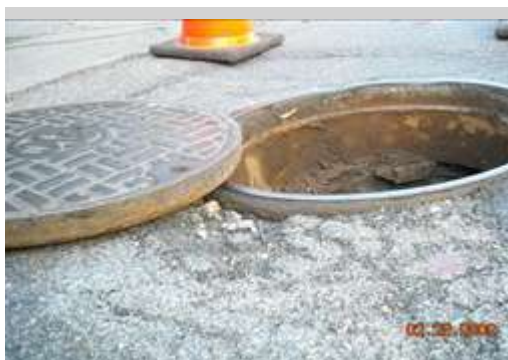
MISC.

SUBJECT TO PONDING DUE TO  
SETTLEMENT AROUND FRAME

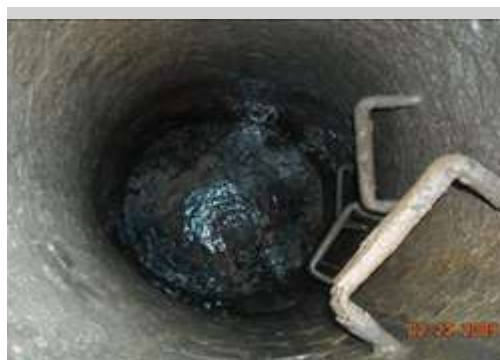
MISC.

Comments **HEAVY CLEANING FROM DOWNSTREAM MANHOLE S21M\_\_040MH TO BREAK THROUGH LARGE GREASE DEPOSITS AND ALEAVIATE SURCHARGE.**

TOP VIEW PRIOR TO CLEANING

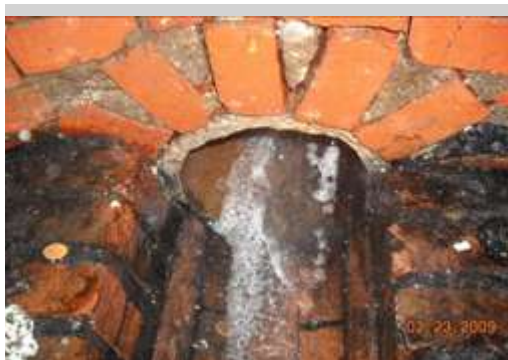
Defect

Condition: ☐ Sound ☐ Cracked ☐ Root Intrusion ☐ Loose Brick ☒ **Deteriorated**

Condition: ☐ Sound ☐ Cracked ☐ Root Intrusion ☒ **Deteriorated** ☐ Leaks ☒ **Debris**

Barrel\_loose bricks, deteriorated, bench  
deteriorated

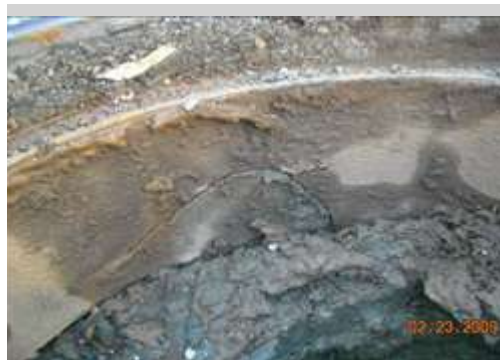
Defect 9

**Frame** Offset: **4** (in.) Condition: ☐ Sound ☒ **Cracked** ☐ Leaks

CRACKED FRAME

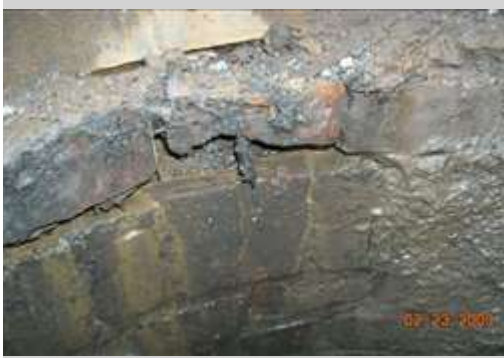
Defect 8

Condition: ☐ Sound ☒ **Cracked** ☐ Root Intrusion ☒ **Loose Brick** ☐ Deteriorated

Infiltration: ☐ None ☒ **Joint** ☐ Cracks ☐ Mortar ☐ Roots ☐ Wall

CRACKED CHIMNEY BRICK and infiltration

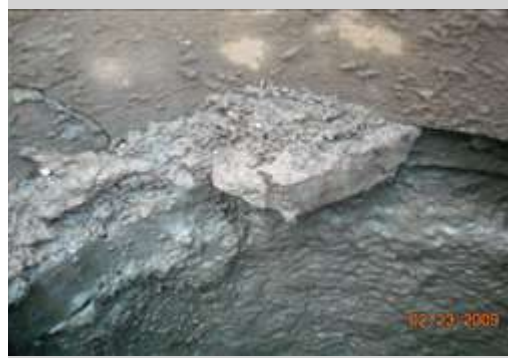
Defect 7

LOOSE CHIMNEY BRICK

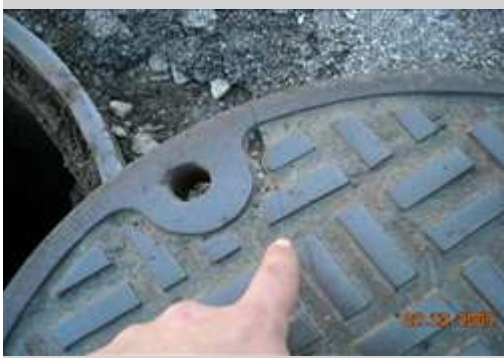
Defect 6

Type: **Sanitary** Condition: **Cracked** Cover Material: **Cast Iron**

CRACKED COVER

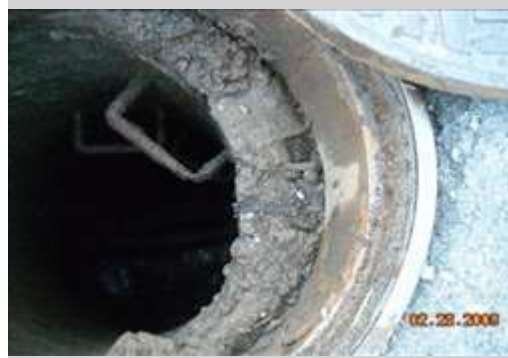
Defect 5

FRAME OFFSET, Leaks

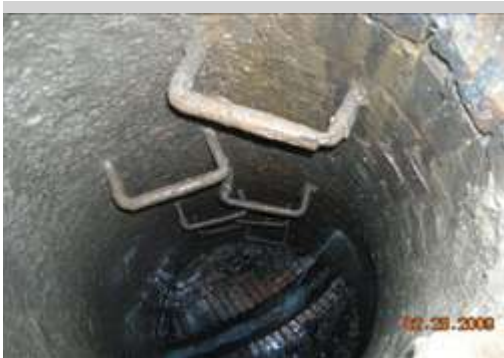
Defect 4

**Steps** Count: **7** Missing: **0** ☒ **Corroded**

CORRODED STEPS

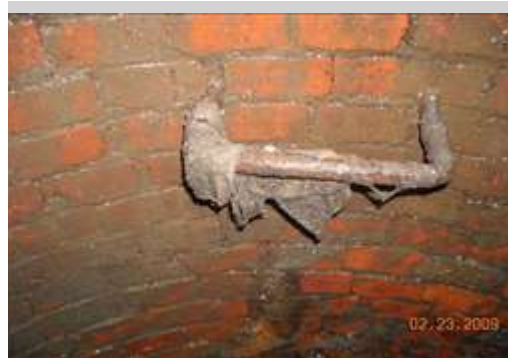
Defect 3

**Surcharge** ☒ **Evidence Of Surcharge** Depth: **4** (ft.) ☐ Active Surcharge Present

EVIDENCE OF SURCHARGE

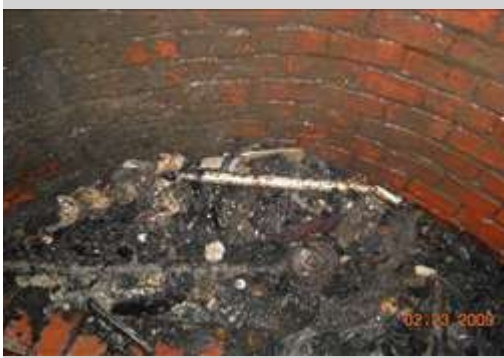
Defect 2

DEBRIS ON BENCH

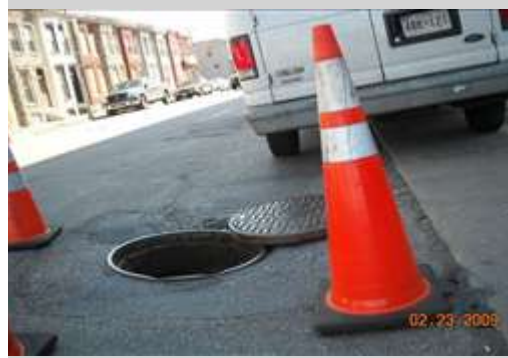
Defect 1

SETTLEMENT OF FRAME AND  
ASPHALT OF 1 INCH BELOW CURB  
BASE

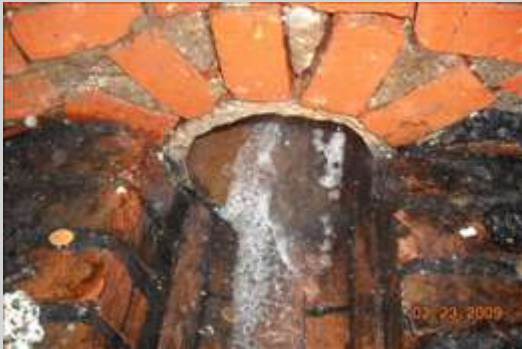
12 O'Clock Outflow

Pipe Height: **8.4** (in.) Rod and Bar (Angled)  
Pipe Material: **Clay** ☐ Pipe Lined  
Invert Depth: **11.65** (ft.) Flow Characteristics: **Slow**  
Deposits: ☒ None ☐ Mud ☐ Sludge ☐ Debris ☐ Grease  
Silt Depth: **0** (in.) Deposits Extent:  
Infiltration: **None** Pipe Seal Cond: **Cracked**

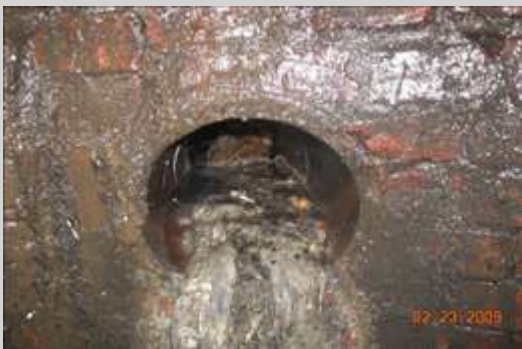
5 O'Clock Inflow

Pipe Height: **8.4** (in.) Rod and Bar (Angled)  
Pipe Material: **Clay** ☐ Pipe Lined  
Invert Depth: **6.90** (ft.) Flow Characteristics: **Slow**  
Deposits: ☐ None ☒ Mud ☒ Sludge ☐ Debris ☒ Grease  
Silt Depth: **3** (in.) Deposits Extent: **Medium**  
Infiltration: **None** Pipe Seal Cond: **Sound**

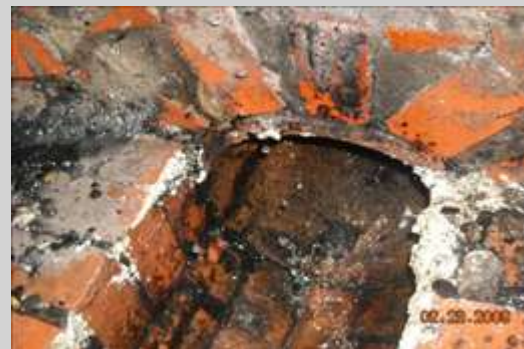
Drop In @ 5 O'Clock

Drop: **Outside** Rod and Bar  
Angled: **Yes** Reading: **10.15** (ft.)  
Inv Depth: **11.15** (ft.)  
Drop Condition: **Clogged**
